COMPACT FRONTWHEEL DRIVE CLUB of AMERICA

SEPT 14, 1979

SAAB Clubs of North America • publisher & treas.: Dick Grossman - 1918 W. Hood- Chicago, Ill. 60660 • phone: 312-743-6742

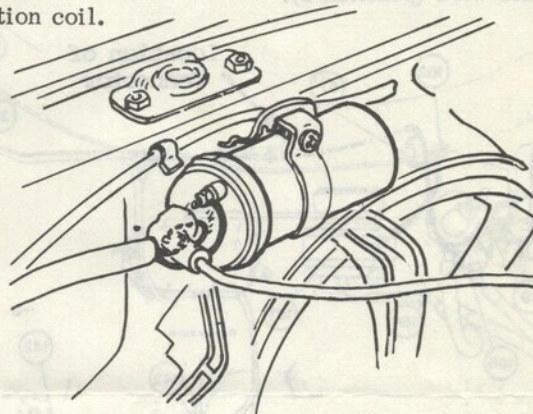
Intermittent ignition misfire can be caused by flashover between the high and low tension connections of the ignition coil. This usually occurs when the primary connections are positioned so that they lie close to the coil tower (secondary or high tension connection).

On VIN'S below 90791030320, 90792003197, 9079600-4344, repositioning the coil in its bracket and repositioning the wires will reduce the possibility of flashover.

1. Loosen the coil mounting clamp and rotate the coil 90 degrees. Reposition the connectors to point toward the rear of the car. Tighten the clamp and correctly position the rubber cover on the coil.
2. Check that the rubber strip between the radiator and radiator member covers the area in front of the ignition coil.

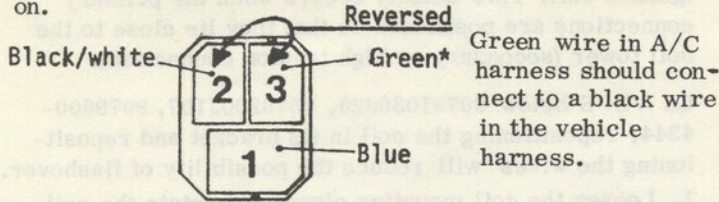
INCORRECT WIRING A/C Harness Connector, Rear View

In air conditioning kits shipped prior to Jan. 19, 1979, wiring harness T-1 has two of the wires installed in incorrect locations in the 3-pole connector.

The symptom of the incorrect wiring is that the main cooling fan will run as soon as the ignition is switched on.

Figure 1 illustrates the incorrect wire positions. Exchange the green wire (position 3) with the black and white wire (position 2).

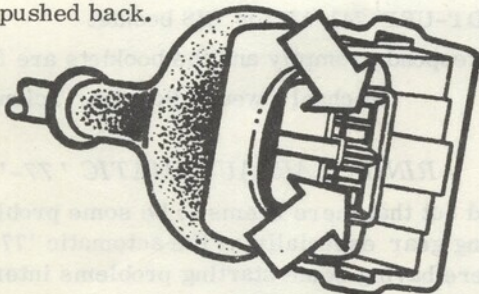
Remove the electrical connector from the component in question and examine to be sure the terminals have not pushed back.

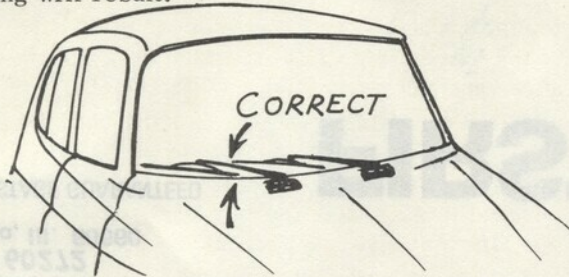
2. Saab 900 wipers park to the right hand position on the windshield. When adjusting or installing new arms be sure that the driver's side arm and blade assembly parks above the passenger side arm and blade. If it is installed below the passenger side arm interference and binding will result.
