# Zenith Console Radio Restoration

## 1939 Model 7S363

## Preface

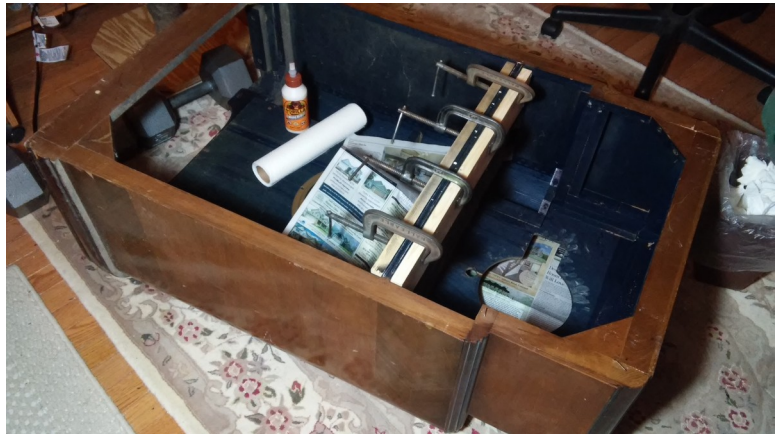
The plywood chassis base appeared solid near its mountings but had severely delaminated at the unsupported back portion. By severely delaminated, I mean that there was a gap exceeding an inch between plies. I doubted that clamping could restore the plies without warping but decided to give it a try. Because the gaps were so large, I was able to just pour undiluted Gorilla wood glue directly into the gaps. I crossed my fingers and clamped with a 1x4 on each side. As I tightened the clamps, I wiped excess glue off as it was squeezed out of the closing gaps.

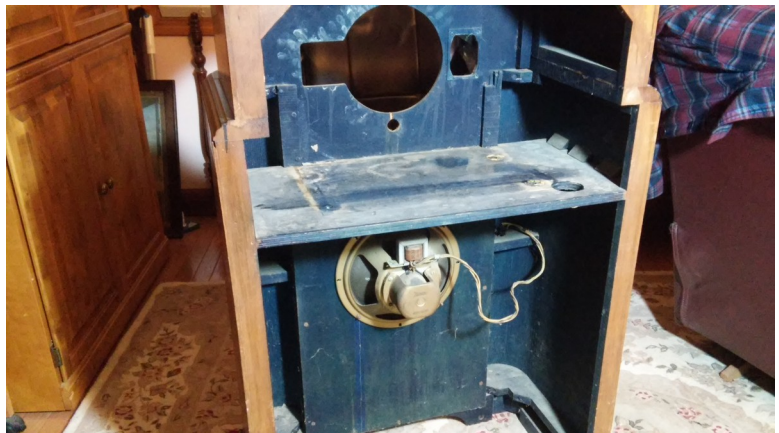
After allowing the wood glue several days to dry, I removed the clamps to find the plywood base was very straight and solid, and as good as new. Well, as good as new except for the dirty appearance. Thus encouraged, I looked for something else simple to restore.

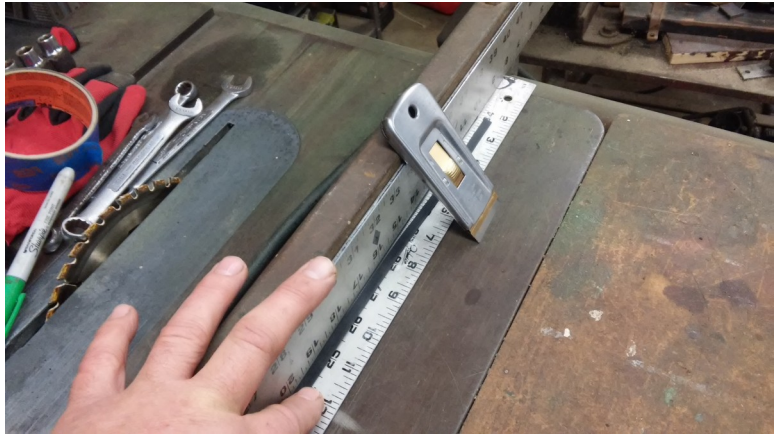
The next thing that caught my eye was the dial glass which was loose in the frame because the rubber edge trim had crumbled with age. I couldn't find any reproduction sources but I found an SBR rubber, U-channel, push-on trim at McMaster Carr, item number 8510K14 (3/32" wide by 21/64" high inside). The rubber is soft and flexible, and all I had to do was trim the excessive height. I found an easy way to trim the excess was by mounting the trim on the edge of an aluminum yardstick, then laying this yardstick on my table saw and pushing the back edge of the rubber up against the guide. Then I found another yardstick of approximately 0.1" thickness and set this edgewise on the rubber trim and used a razor tool to cut the excess as shown in the photo. The resulting cut was very straight and the trim looked factory made.

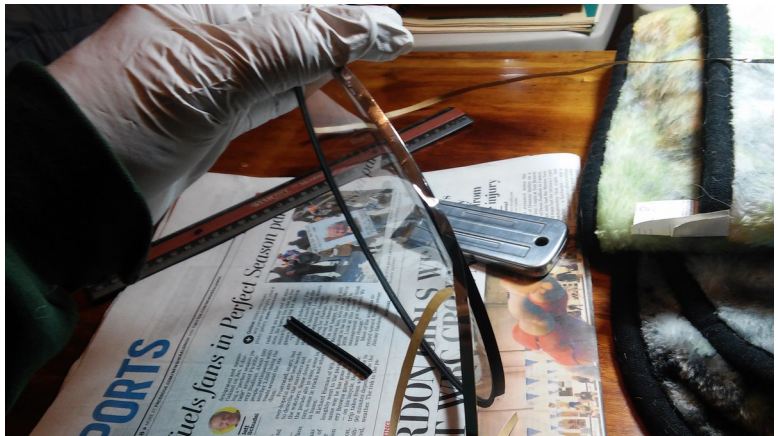
Rather than risk making a mess by gluing the trim onto the glass, I applied a band of aluminum tape around the trim so that it couldn't expand outward. This held the trim securely in place.

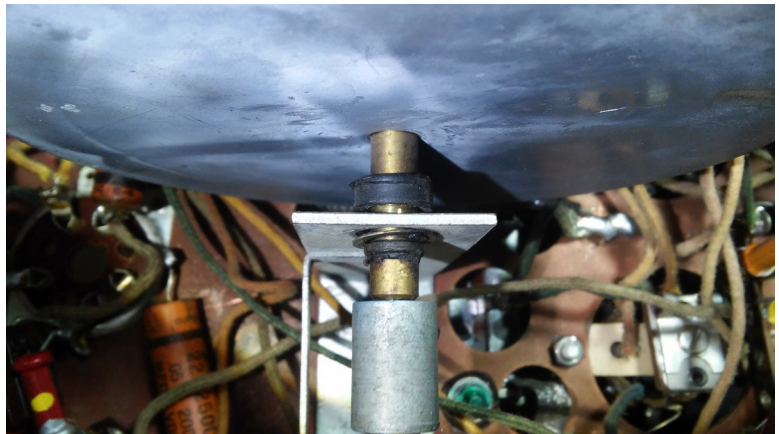
I turned my attention to the dial shaft and first noticed that the back-end nylon bearing had popped out of its mounting hole, and it didn't want to stay in place if I pushed it in.

Further dial shaft investigation revealed the the front-end bearing liked to pop out of the chassis wall, and a nylon band on the pulley had snapped. I couldn't find replacement parts online so I decided to ponder on this in the back of my mind while I moved on to another task.

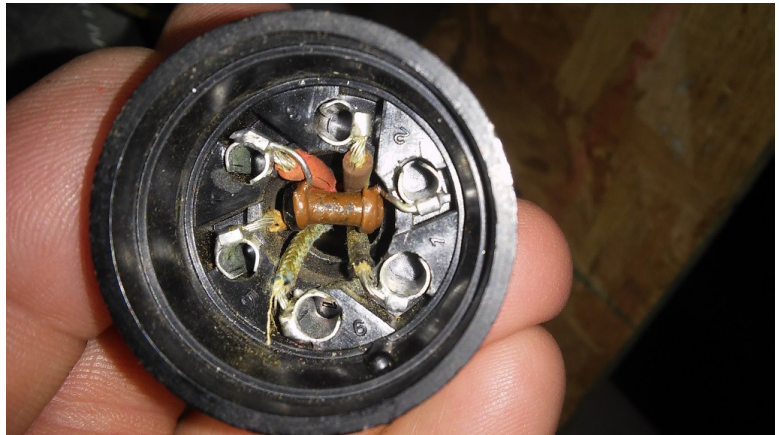
There is a 1 megohm resistor (R15) connecting pin 2 (triode plate) to pin 4 (target) of the 6U5 indicator tube (Magic Eye). This resistor is inconveniently mounted in the base of the socket as shown in the photo. This resistor measured over 5 megohm and needed to be replaced. Gaining access required removing a Bakelite disk holding the circular contacts in place. I found it impossible to pry the disk out but I cut a short length of wood, about 2", off of an extra long matchstick. The wood was soft and just fit through the wire hole. I slid it in past the resistor until it contacted the disk. With the socket placed face down on a table top, a gentle tap on the stick with a small hammer popped it out without damage. Note also that the B+ wire to pin 4 had crumbled rubber insulation and also needed to be replaced.

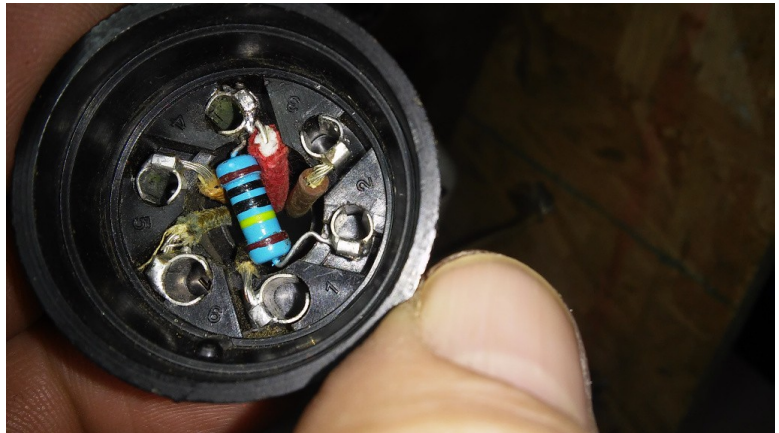
This photo shows the socket with the new resistor (1 megohm metal film, 1 watt) and a new B+ wire. After pressing the Bakelite disk back into place, this repair was complete.

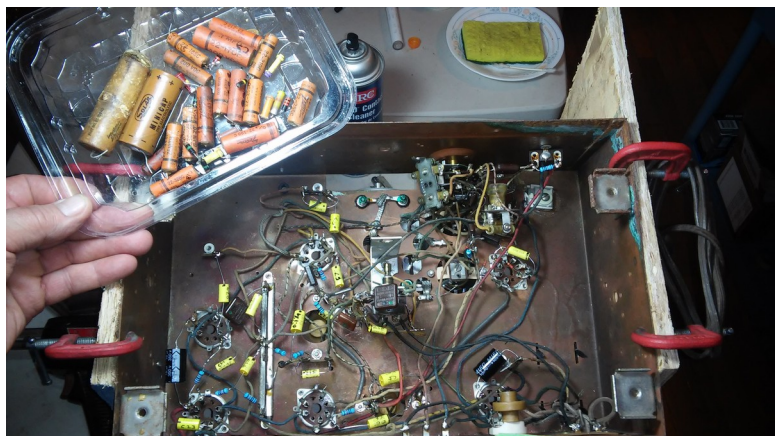
This photo shows the rewired chassis and the removed components. You might notice that the original paper film capacitors had a black band on one end. I didn't know what this was, and it made no sense since these are not polarized capacitors. A little research and I found out that the black band indicates which lead is connected to the outer foil. These capacitors are formed by rolling two foils together with an insulating material sandwiched between. Well, one of the foils ends up on the outside. Does it matter? Well, yes, sometimes. Stray electromagnetic radiation in the chassis strikes the outer foil first. This can cause undesirable effects such as noise, oscillation, etc. The capacitors were therefore installed with the outer foil connected at ground, or at the end with the

lowest impedance path to ground. This had the effect of damping the stray signals and minimizing their effects.

Well, newer poly film capacitors don't have the above-described band. Supposedly, they have an additional wrap or cylinder of shielding foil that blocks some of the radiation. Still, however, it is good practice to determine which lead is connected to the outer foil. I simply held the plastic portion between a thumb and finger, and then alternately connected each end to a sensitive amplified speaker. I could hear the hum from room radiation being injected into the capacitor. The lead that produced the loudest hum was connected to the outer foil, and I placed a black dot on the corresponding end of the plastic. I then installed the new capacitors in the same orientation as the originals. The black dots are visible in the photo.

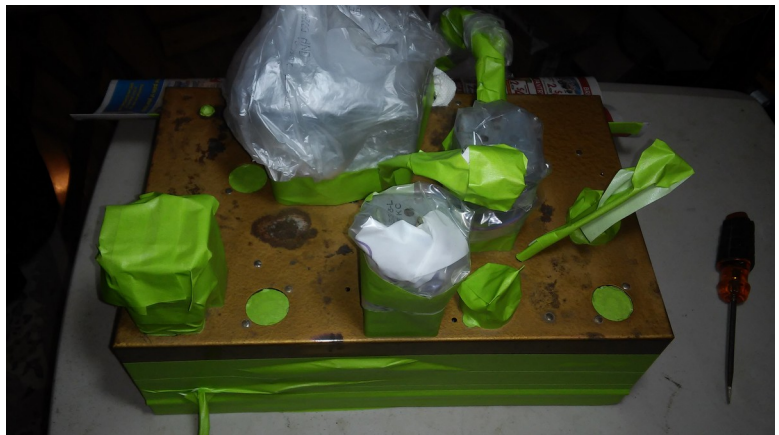
This photo shows the chassis masked for painting. The mouse urine created some deep rust pockets even on the top of the chassis. I wire brushed and sanded but didn't worry too much about a little rust and roughness. The paint I was using was Masterchem Industries 41170 Hammerite Spray Paint, 12 oz, Gold. On the spray can, it is described as hammered finish, paint and primer and paint right over rust.

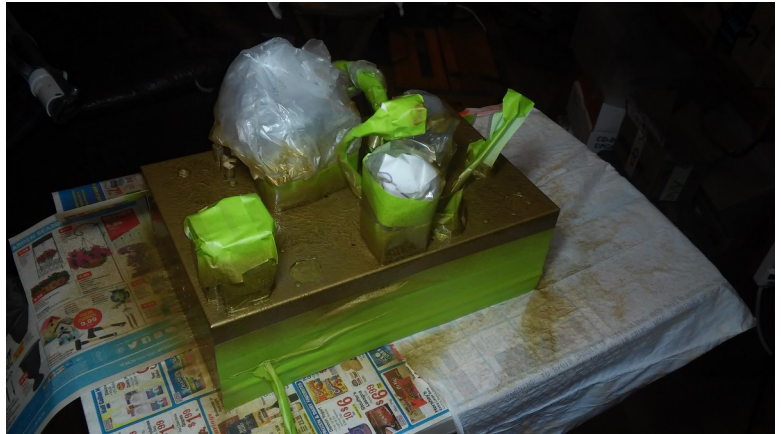
This is after a single coat of the Hammerite spray paint. The single coat provided very good coverage.

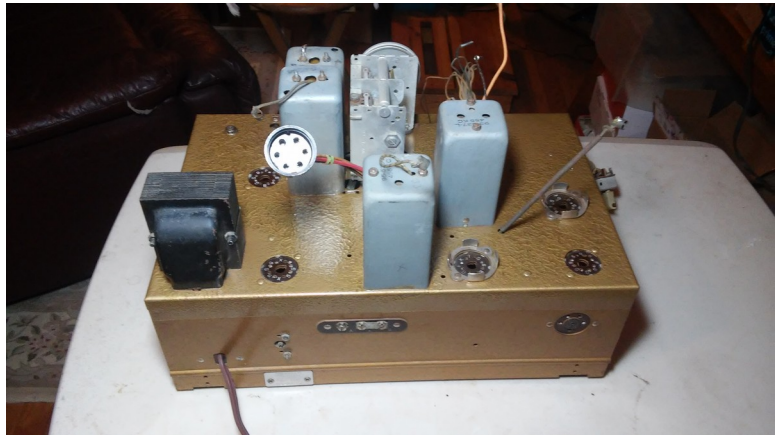
After removing the masking, this rear view shows how well the paint covered and removed all traces of roughness. If you look at the masking line just above the antenna terminals, you can see that it is a reasonably good match to the original, not perfect but good enough for me.

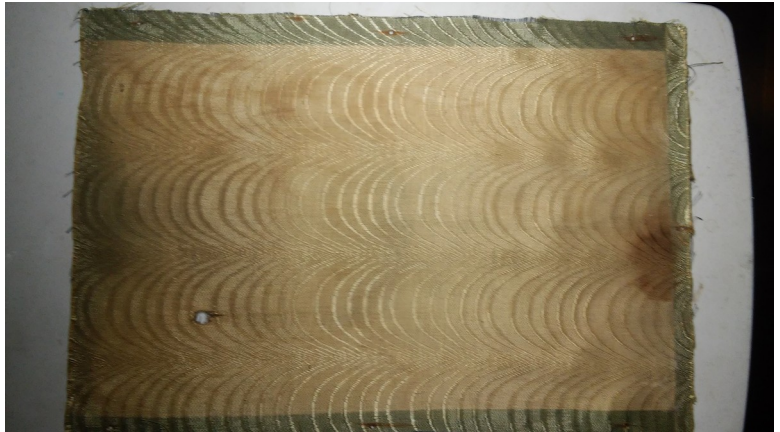
It was now a good time to work on the speaker board and cloth. The original wave design cloth peeled off rather easily. Obviously not reusable.

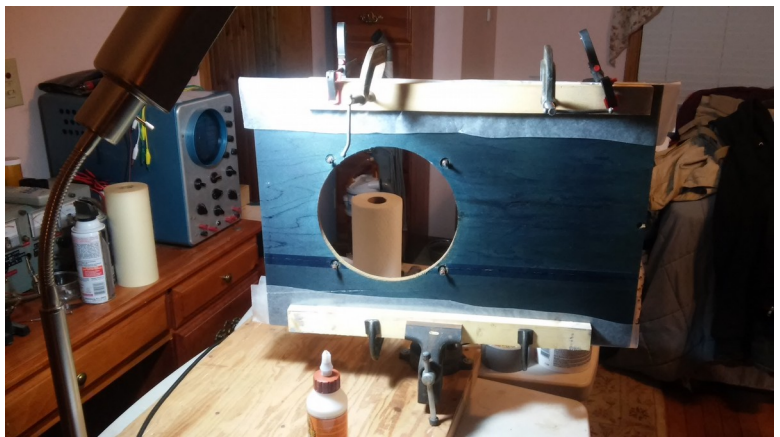
The board required minimal re-laminating on the side edges. This time, however, I laid waxed paper over the edges before clamping to make for clean removal of the clamp lumber.

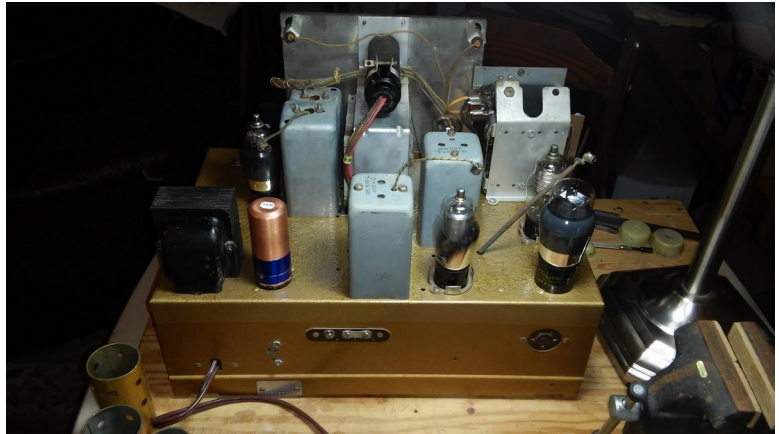
I used a vintage Conar tube tester to test the tubes, and I replaced one weak tube with an NOS tube. The 6X5G rectifier tube tested as having a heater to cathode short. These tubes were infamous for killing power supply transformers because of this tendency to short. Fortunately, this transformer is A-OK, but I opted to replace the tube with a copper top, solid state replacement as can be seen in the photo. The WX5 Copper Cap from Weber Vintage Sound Technology is designed to work as a direct replacement for the 6X5 tube (<https://www.tedweber.com/wx5>). I hadn't yet replaced the tube shields.

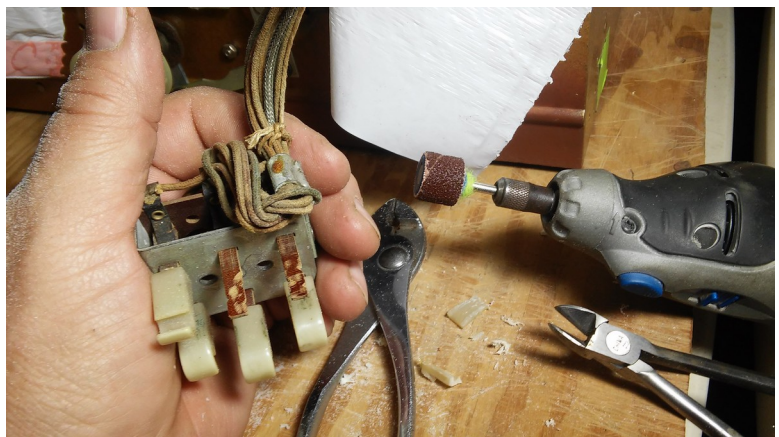
Several push/pull buttons were missing or broken. The broken tone control buttons were a problem because they were glued or molded onto phenolic stems, tough but breakable. I found it easy to gingerly grind off the top of the buttons with a coarse sanding drum on my Dremel tool, stopping on first sighting of the phenolic board. The bottom half of the button then practically fell off on its own power.

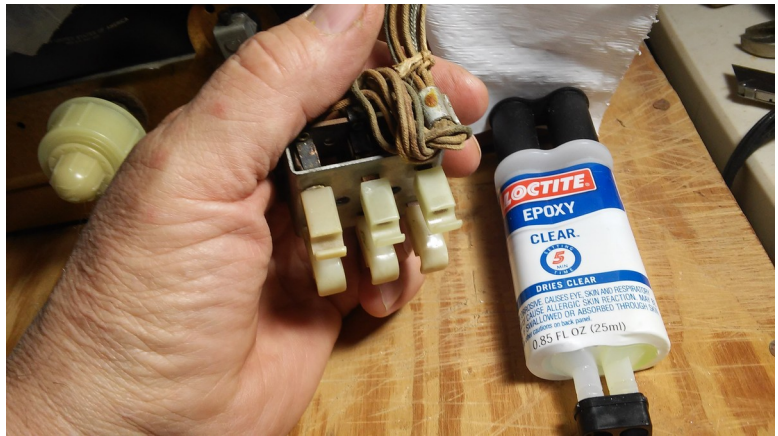
I glued the replacement buttons on with clear epoxy, but care has to be taken here! The replacement buttons were good quality but didn't quite fit onto the phenolic when I test fit them. They had to be enlarged slightly with appropriate drill bits until they fit smoothly. I sourced replacement buttons and knobs from Renovated Radios LLC (renovatedradios.com).

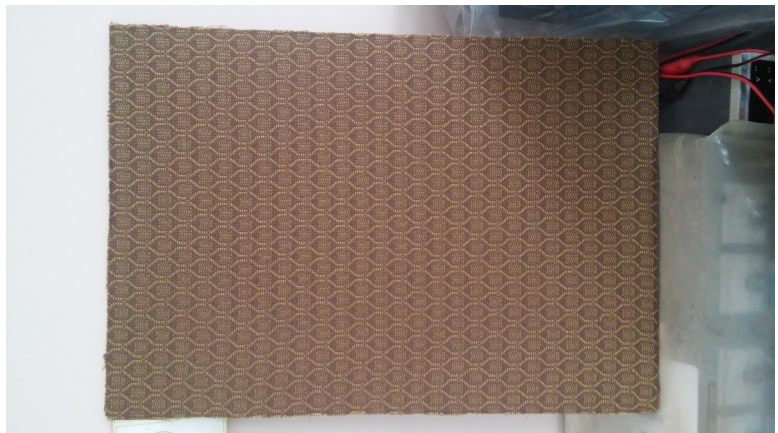
In this photo, I have just attached it to the board with a heavy coat of 3M Super 77 contact adhesive. This stuff grabs immediately and permanently! I made practice runs without adhesive. I didn't dare to just lay the cloth on because the adhesive was so unforgiving. So, I rolled the cloth onto a length of 1-1/4" or 1-1/2" PVC pipe and then practiced unrolling it onto the board until I felt confident. Happily, I got it nearly perfect on my first attempt. If I remember correctly, I trimmed with scissors after installing.

The dark area on the cloth is dark because I had just lightly misted both sides of the cloth over the speaker opening. The resulting shrinkage almost immediately removed all sag and tightened the cloth over the opening.

This is the finished board, and the real colors are much more vibrant than the photo shows.

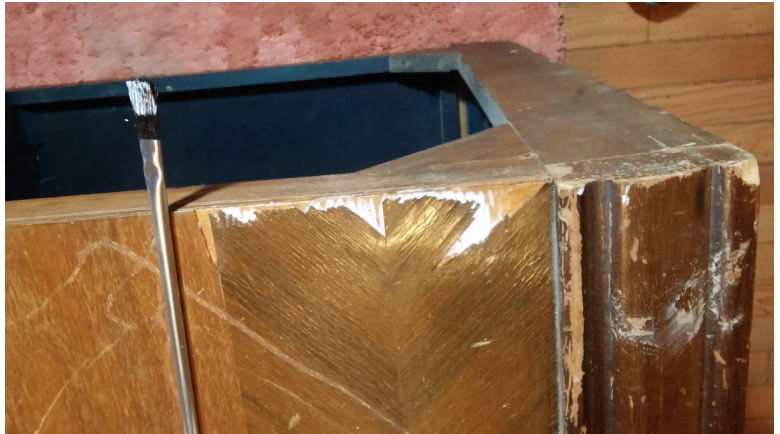
This is a view of the bottom, right (as viewed from the front), rear of the cabinet. The left rear was in similar shape. The veneer was pretty decent everywhere else on the cabinet. It looks like these lower back corners took the brunt of hits by wayward feet, vacuum cleaners and whatnot. At this point, I was re-gluing the peeling veneer while I pondered how I would fix this.

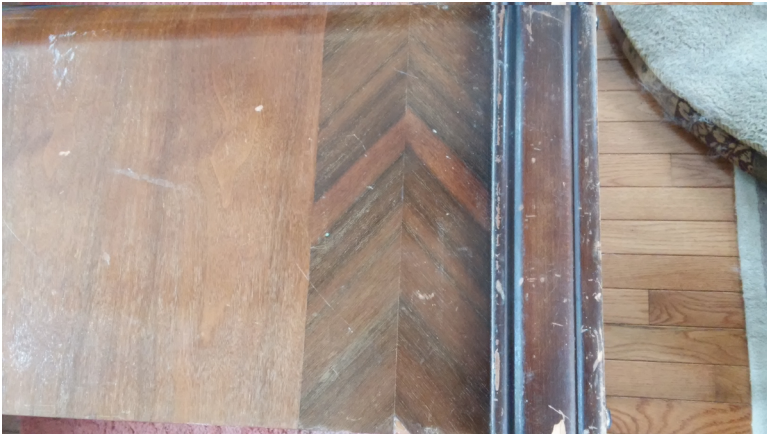
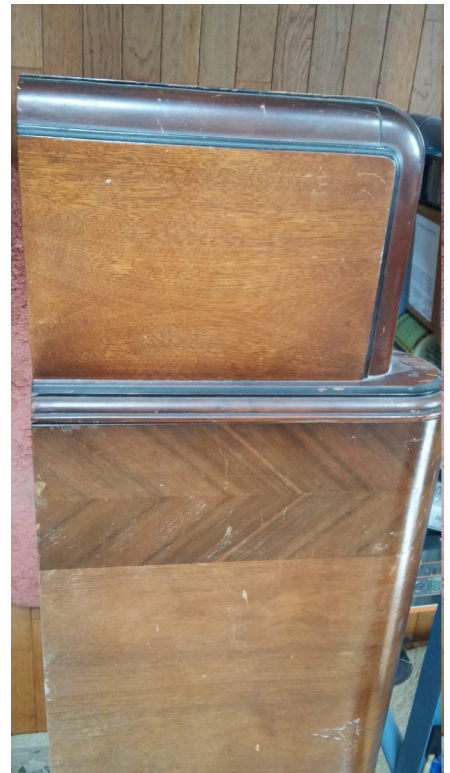
This left side view shows the veneer to be in decent shape except for a few chinks here and there. ==>

Another left side view showing most damage to be toward the bottom rear.

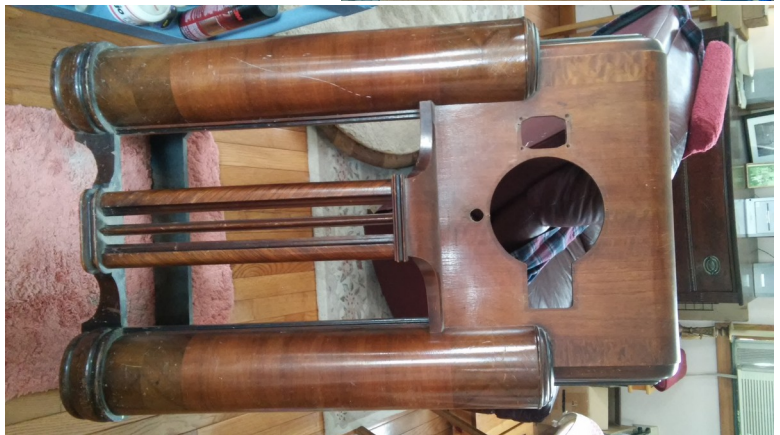
The front of the cabinet was in good shape except for a few chips and the veneer on the two narrow center posts was starting to peel.

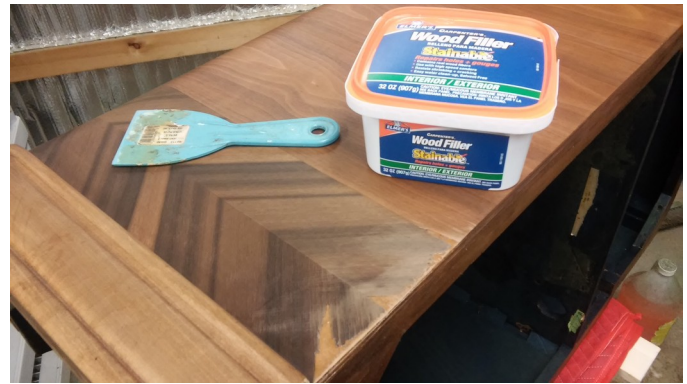
I decided that replacing veneer was beyond my capabilities so I started filling missing chunks with a stainable wood filler. As it turned out, large areas like this were simply not going to look good. A better solution was to make some kick/scuff plates as described a little later.

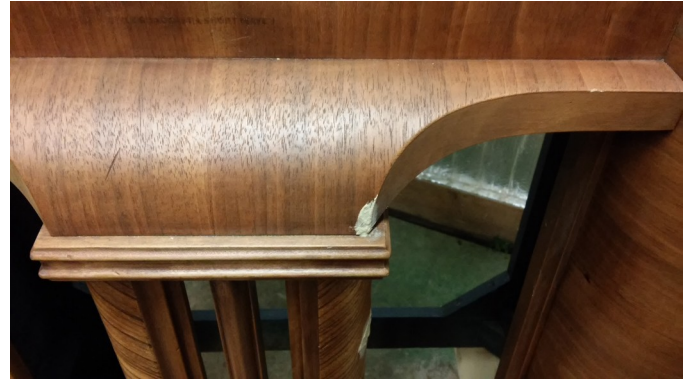
Small areas like this were barely noticeable after staining and refinishing.

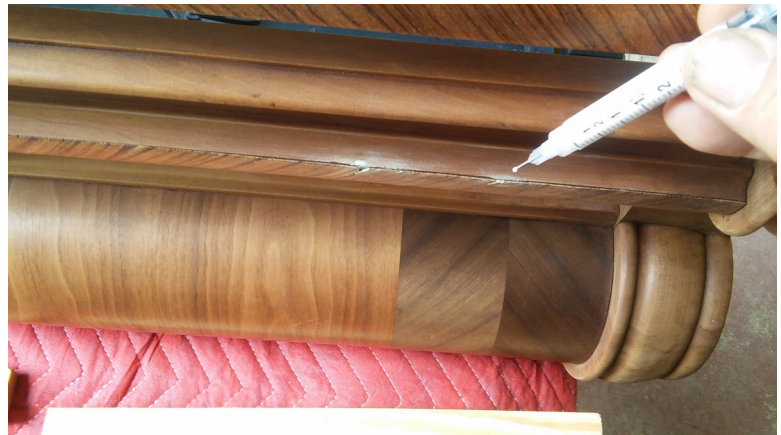
The veneer on the vertical bars in front of the speaker was delaminating in several areas. The Gorilla wood glue was much too thick to work with here but thinning solved the problem. We give our alpacas monthly shots and, therefore, I had a number of syringes with needles on hand. I thinned the wood glue to an appropriate consistency and trimmed the needle back to a shorter length to eliminate flex. The syringe worked very well for injecting the thinned glue into the narrow gaps.

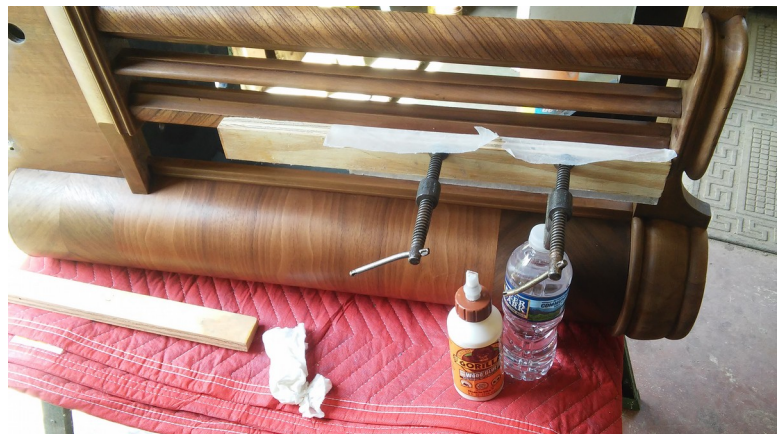
Clamping the vertical bars with 1x2 wood and waxed paper.

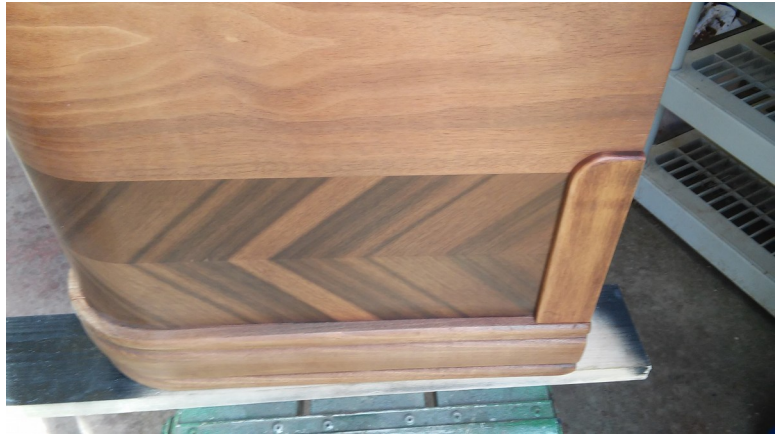
I mentioned earlier that wood filler wasn't going to look good over large areas. It seemed to me that Zenith would have been well-advised to install scuff plates on the bottom, rear of the sides because vacuum cleaners and what-not seemed likely to damage these areas. For me, it also seemed like a good solution for covering the missing veneer and protecting against future damage. I think my home-made scuff plates look good.

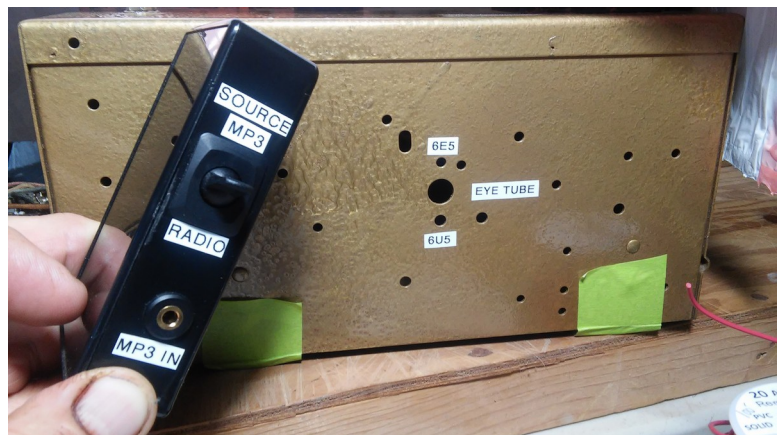
This photo shows an adapter I mounted in the back of the cabinet for playing either the radio or an external source such as an MP3 player. It also shows the side of the chassis where I mounted a switch for the magic eye tube, for either an original 6U5 or the replacement 6E5. More on this later.

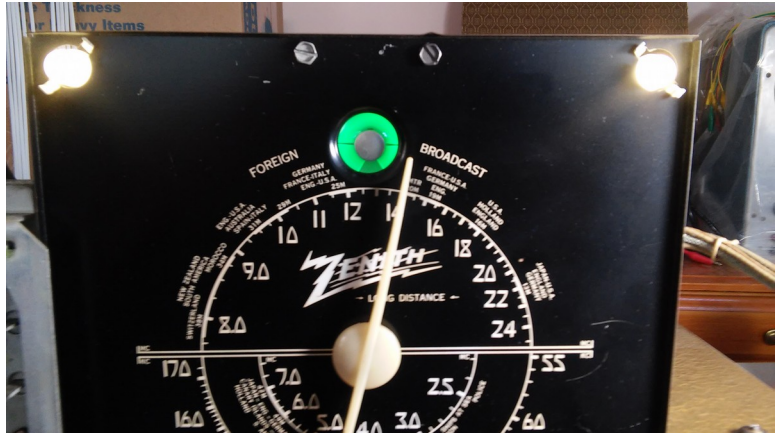
This is a test of the nice-and-bright 6E5 tube with no input signal (fully open).

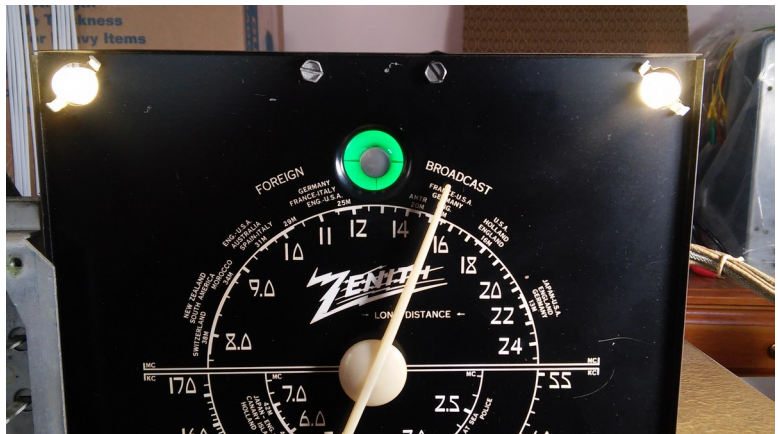
This is a test of the 6E5 tube with a strong input signal (fully closed).

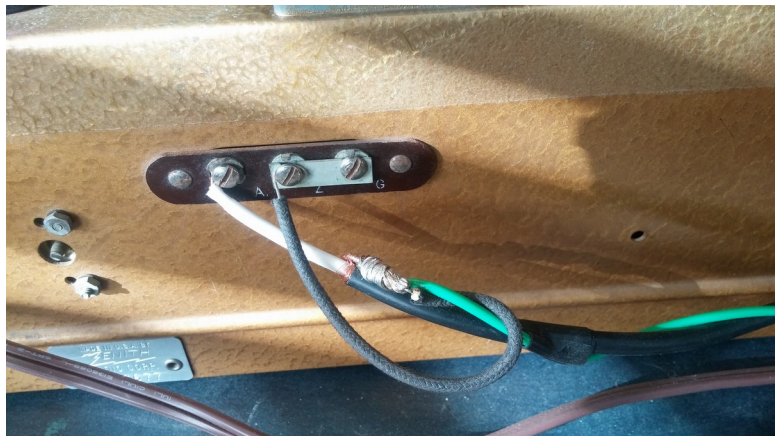
A view of the antenna connections. I have a shorter-than-recommended long wire antenna in the attic. Because of our noisy electrical environment, I had to bring the signal down through a 100 foot 75 ohm coax cable. And then, because the cable was apparently a lousy impedance match to the long wire antenna, I didn't get a usable signal at the radio. So, I experimented with antenna amplifier circuits I found online that worked with AM broadcast. Unfortunately, these all failed due to saturation caused by stronger electrical interference. I then resorted to designing and making my own noise-tolerant antenna amplifier which works well. More on that later.

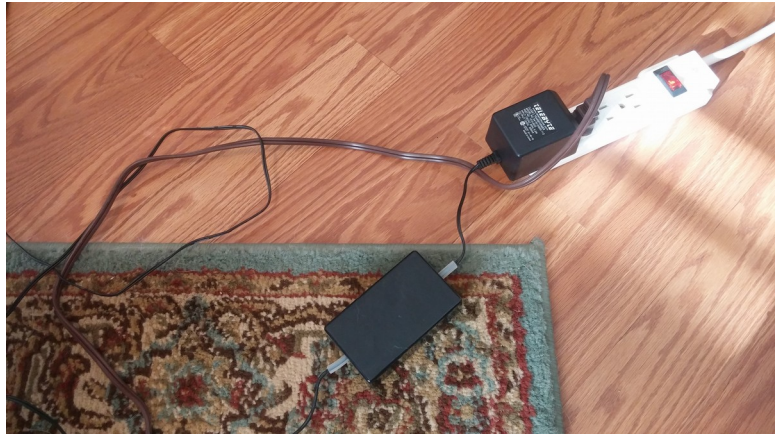
This is power for my antenna amplifier. The transformer is an old-fashioned transformer type ac-dc adapter wired into a 9V regulator circuit in the plastic box. Newer switching-type adapters don't work here because they inject too much noise into the amplifier. That's the nature of switching-type power supplies.
