COMPACT FRONTWHEEL DRIVE CLUB of AMERICA

SEPT 14, 1979

SAAB Clubs of North America • publisher & treas.: Dick Grossman - 1918 W. Hood- Chicago, Ill. 60660 • phone: 312-743-6742

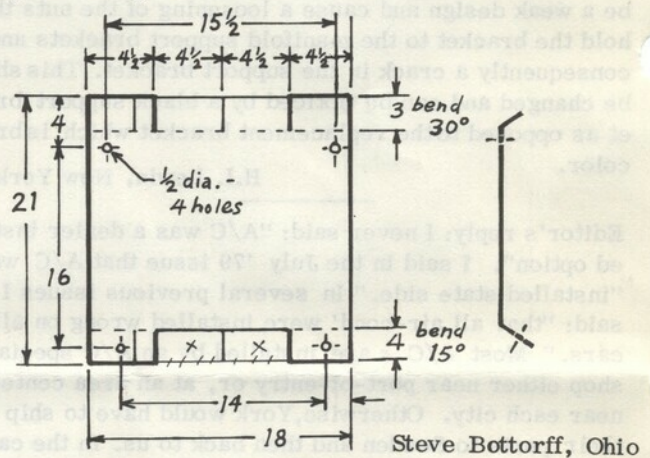
Skid plate design - All dimensions in inches.

Recommended material for this plate is either 1/8" or heavier steel or 3/16" - or heavier aluminum. The 2 areas marked "X" may be eliminated without any loss of strength. If difficulty is encountered while tightening the front edge to the rounded profile of the car, cut each of the leading edge cuts into a shallow "V".

The plate is an ideal place to mount a front tow ring. Use a heavy duty "U" bolt (not muffler quality) with nuts above and below the skid plate. Mount the "U" bolt toward the left side to avoid hitting the oil pan.

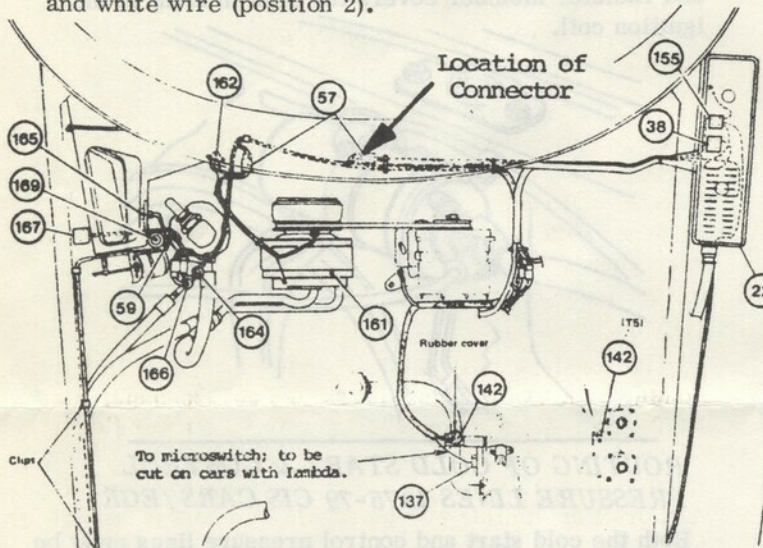
INCORRECT WIRING A/C Harness Connector, Rear View

In air conditioning kits shipped prior to Jan. 19, 1979, wiring harness T-1 has two of the wires installed in incorrect locations in the 3-pole connector.

Figure 1 illustrates the incorrect wire positions. Exchange the green wire (position 3) with the black and white wire (position 2).

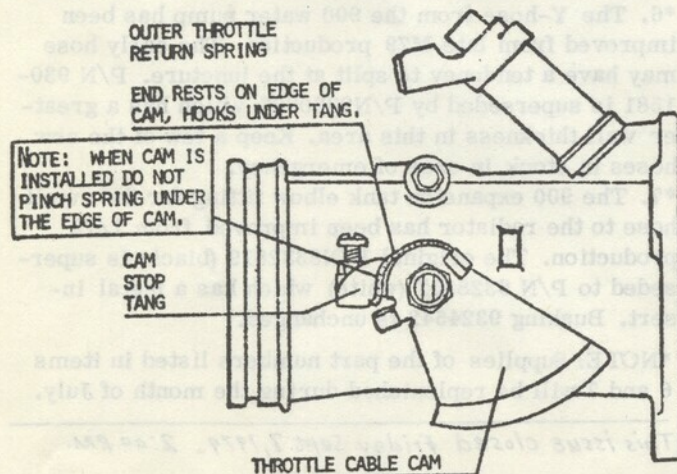
9. Reinstall all the parts checking for freedom of movement after each item is installed. (Use Loctite on throttle plate screws.) Install new type return springs (P/N's 93 06 184 and 93 06 192) making sure they are completely free of all adjacent hardware and exert full tension at their anchor points.

10. Adjust throttle stop. (STOP SCREW IS NOT TO BE USED TO SET IDLE SPEED.)

- a. Back out the stop screw until the throttle plate is completely closed.
- b. Turn the stop screw in until it just contacts the throttle arm.
- c. Turn the screw 1/3 additional turn and tighten the lock nut.
