COMPACT  
FRONTWHEEL  
DRIVE CLUB  
of AMERICA

SEPT 14, 1979

DEDICATED TO SMALL-  
ENGINEED SMALL CARS &  
ENERGY CONSERVATION

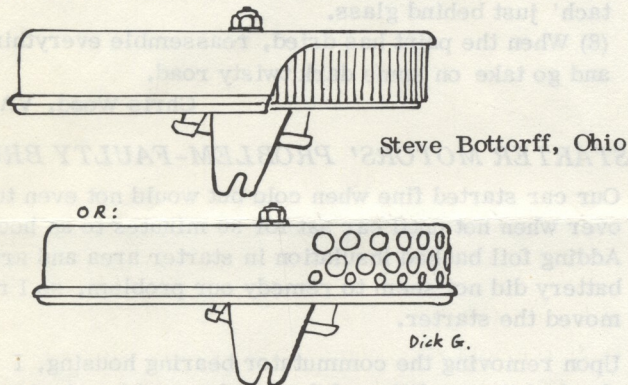
The air cleaner should be modified as illustrated.

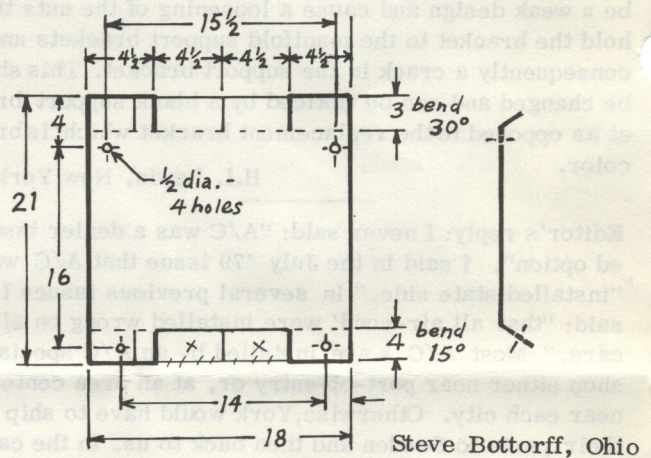
Skid plate design - All dimensions in inches.

Recommended material for this plate is either 1/8" or heavier steel or 3/16" - or heavier aluminum. The 2 areas marked "X" may be eliminated without any loss of strength. If difficulty is encountered while tightening the front edge to the rounded profile of the car, cut each of the leading edge cuts into a shallow "V".

The plate is an ideal place to mount a front tow ring. Use a heavy duty "U" bolt (not muffler quality) with nuts above and below the skid plate. Mount the "U" bolt toward the left side to avoid hitting the oil pan.

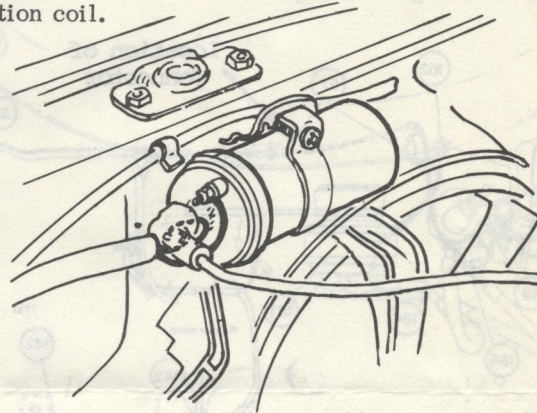
Intermittent ignition misfire can be caused by flashover between the high and low tension connections of the ignition coil. This usually occurs when the primary connections are positioned so that they lie close to the coil tower (secondary or high tension connection).

On VIN'S below 90791030320, 90792003197, 9079600-4344, repositioning the coil in its bracket and repositioning the wires will reduce the possibility of flashover.

1. Loosen the coil mounting clamp and rotate the coil 90 degrees. Reposition the connectors to point toward the rear of the car. Tighten the clamp and correctly position the rubber cover on the coil.
2. Check that the rubber strip between the radiator and radiator member covers the area in front of the ignition coil.

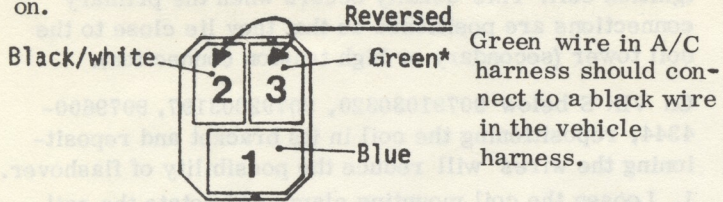
### INCORRECT WIRING A/C Harness Connector, Rear View

In air conditioning kits shipped prior to Jan. 19, 1979, wiring harness T-1 has two of the wires installed in incorrect locations in the 3-pole connector.

The symptom of the incorrect wiring is that the main cooling fan will run as soon as the ignition is switched on.

Figure 1 illustrates the incorrect wire positions. Exchange the green wire (position 3) with the black and white wire (position 2).

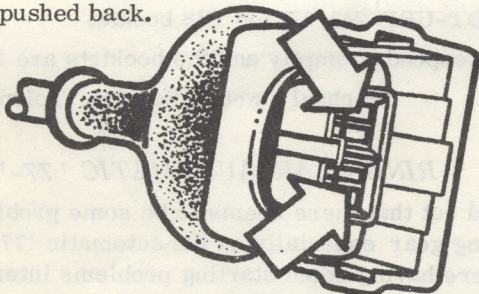
Remove the electrical connector from the component in question and examine to be sure the terminals have not pushed back.

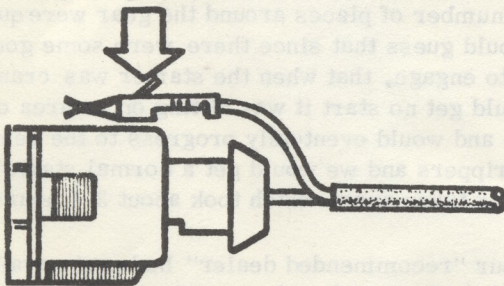
If the terminals can be or are pushed back, remove the rubber sleeve, extract the terminal, and bend the locking flange outward.

Reinstall terminals and sleeve on connector and plug onto the component.

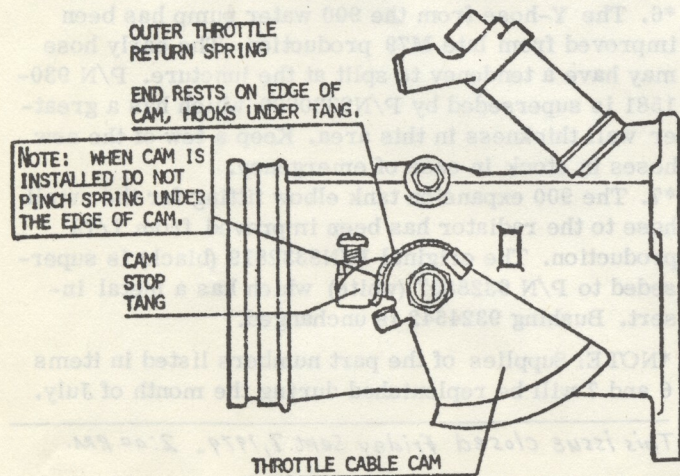
9. Reinstall all the parts checking for freedom of movement after each item is installed. (Use Loctite on throttle plate screws.) Install new type return springs (P/N's 93 06 184 and 93 06 192) making sure they are completely free of all adjacent hardware and exert full tension at their anchor points.

10. Adjust throttle stop. (STOP SCREW IS NOT TO BE USED TO SET IDLE SPEED.)

- a. Back out the stop screw until the throttle plate is completely closed.
- b. Turn the stop screw in until it just contacts the throttle arm.
- c. Turn the screw 1/3 additional turn and tighten the lock nut.

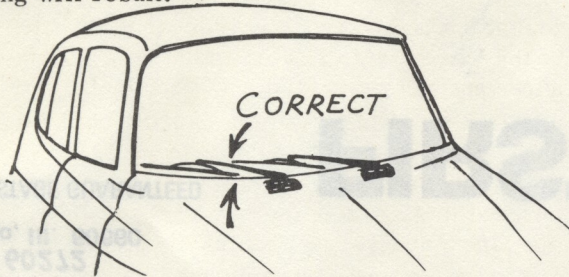
2. Saab 900 wipers park to the right hand position on the windshield. When adjusting or installing new arms be sure that the driver's side arm and blade assembly parks above the passenger side arm and blade. If it is installed below the passenger side arm interference and binding will result.

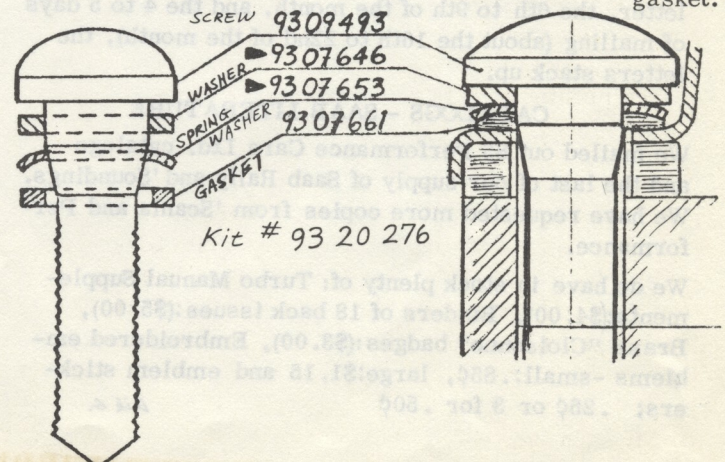
Installation: Any oil or grease should be removed from around the screw holes on the valve cover flange prior to installation. Torque screws 1.5 ft. lbs (2Nm/0.2 kpm).

**NOTE:** Over tightening will reduce the efficiency of the gasket.
