COMPACT  
FRONTWHEEL  
DRIVE CLUB  
of AMERICA

# 115  
MAY '83

DEDICATED TO SMALL-  
ENGINED SMALL CARS &  
ENERGY CONSERVATION

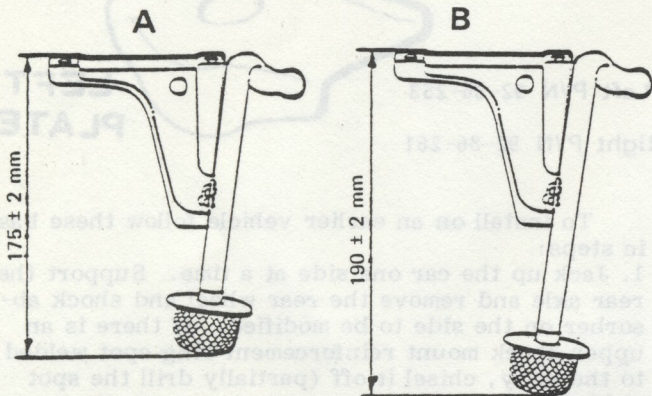
Two different engine oil suction pipes are used in H-engines depending on whether the car has automatic or manual transmission. They are:

A. Part No. 93 09 626, automatic transmission  
B. Part No. 93 44 763, manual gearbox

Use of the wrong one will definitely cause lubrication problems and severe engine damage.
