THE  
**SAAB**  
CLUB

COMPACT  
FRONTWHEEL  
DRIVE CLUB  
of AMERICA

OCT. 14, 1979

Newsletter #76, our 59th multipaged monthly. Dues for membership/subscription are \$9.00 for the first year, including two back copies, 12+ tech' sheets and emblem. Renewal dues: \$5.00. Past dues notification will be rubber stamped on the open rectangle at the top of this page. A treasurer's report will be made three times a year. This is a non-profit organization.

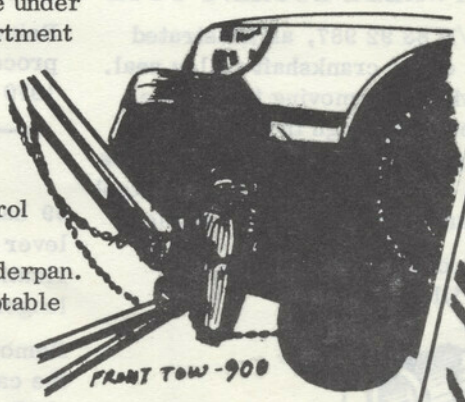
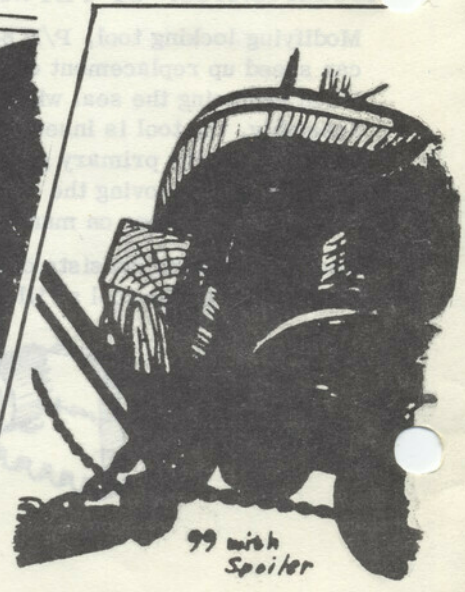
1. Attach J hooks to outboard ends of lower control arms (near ball joint).
2. Position 4x4 and spacer blocks under bumper forward of spoiler.
3. Position tow bar under 4x4.
4. Attach safety chains to lower control arms.

Basic towing procedures are the same for all Saab models. The equipment used for this illustrates in this S.I. was manufactured by Holmes and was selected due to its widespread use. Detailed equipment information may be found in the 1978 AAA Towing Manual.

EXTREME caution must be exercised using the above procedure as hard braking may cause the 4x4 to roll against the spoiler.
